REDTRONIC IP69K TEST CERTIFICATE

Company : Redtronic Ltd
Address : Unit 1-9, Wellington Business Park, Quebec Street, Elland, HX5 9BX,
United Kingdom
Sample Name : BX61 GRILLE LAMP
Date Tested : 19th November 2019

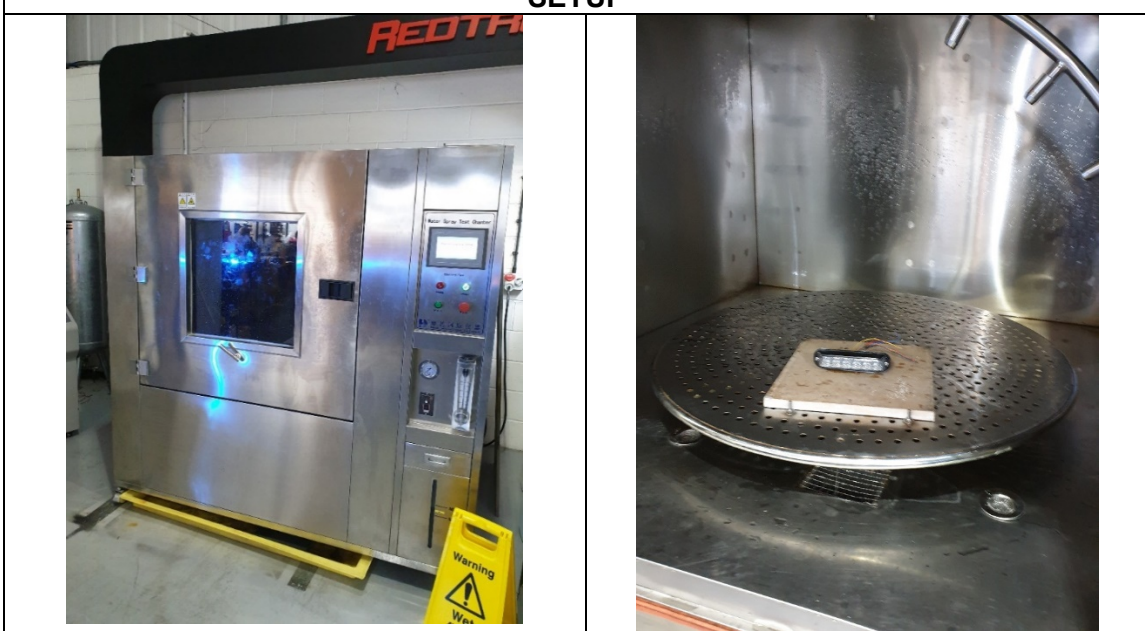
SETUP

Distance of the Nozzle to the specimen:	100 to 150mm
Water flow rate:	15l / min
Water pressure:	100 bar
Water temperature:	80°C
Speed test table:	5 U / min
Spray angle:	0°, 30°, 60°, 90°
Number of cycles:	1
Test Conditions:	The specimen is not in electrical operation.

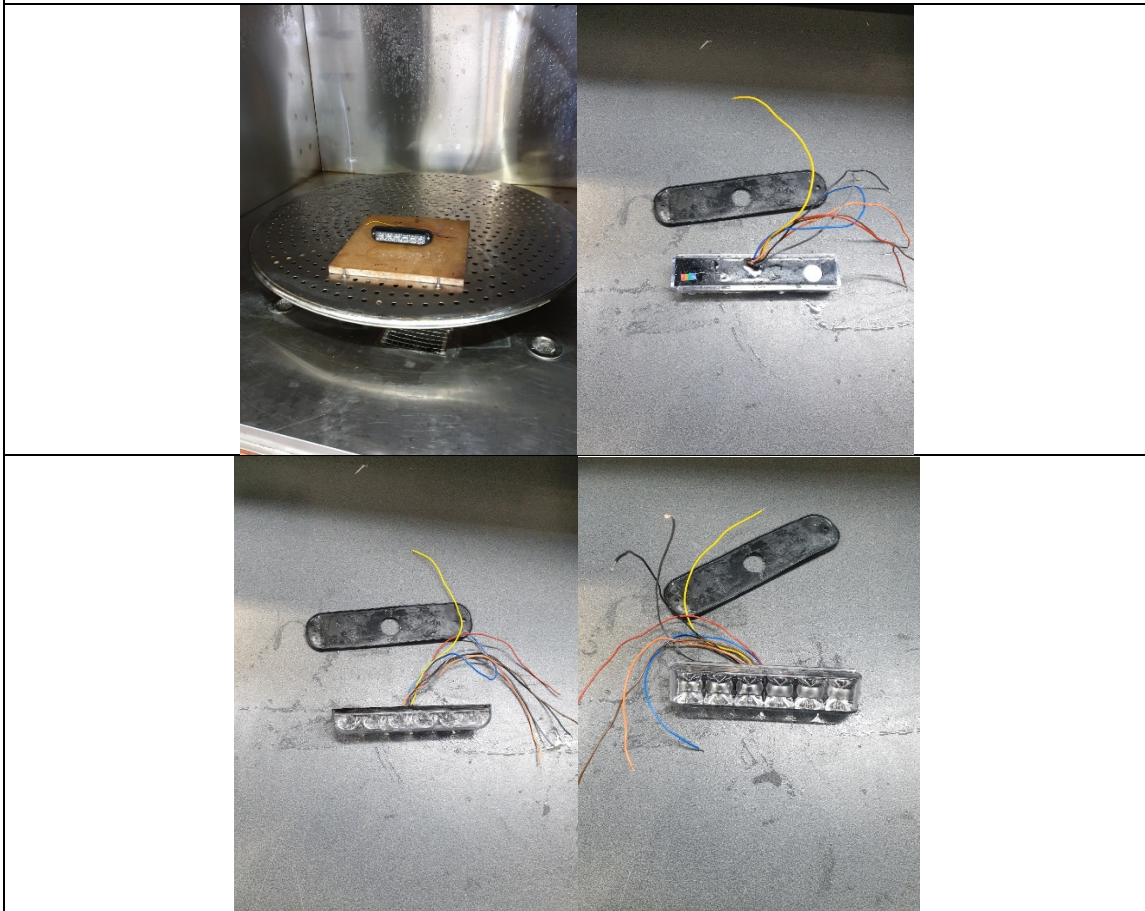
AFTER TESTING

After testing, visual inspection showed no water permeated into the unit.

Comments: Device passed IPX9K test with no negative reaction. Lamp worked both at beginning of test cycle, during and after test cycle complete.

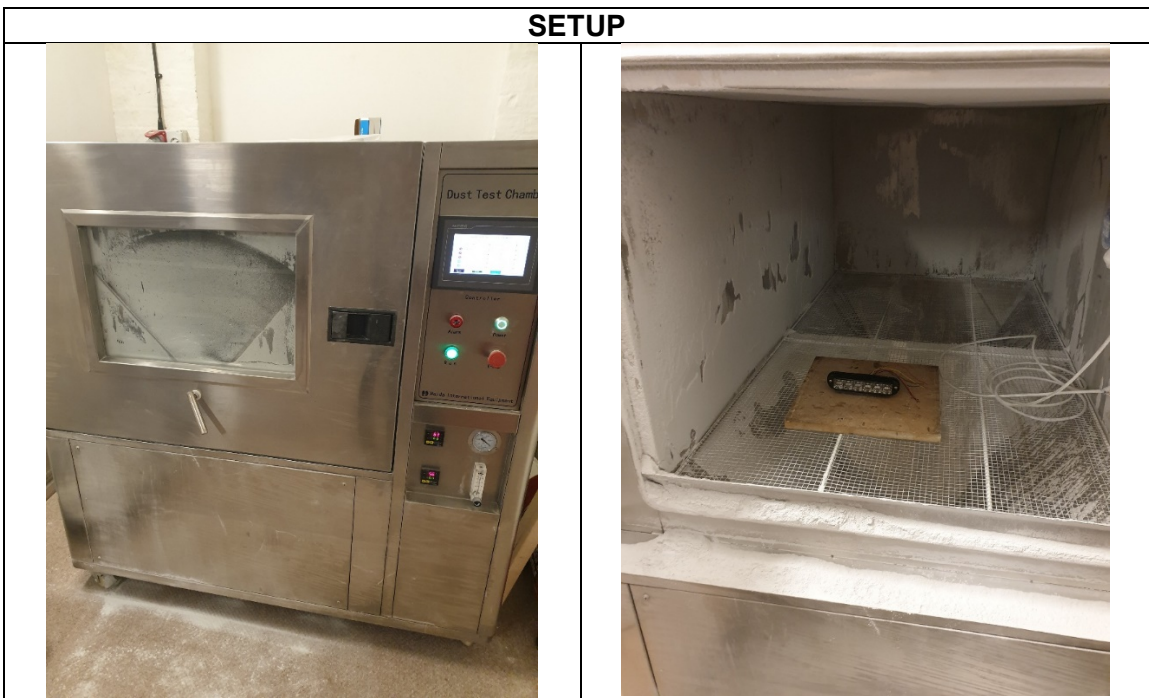
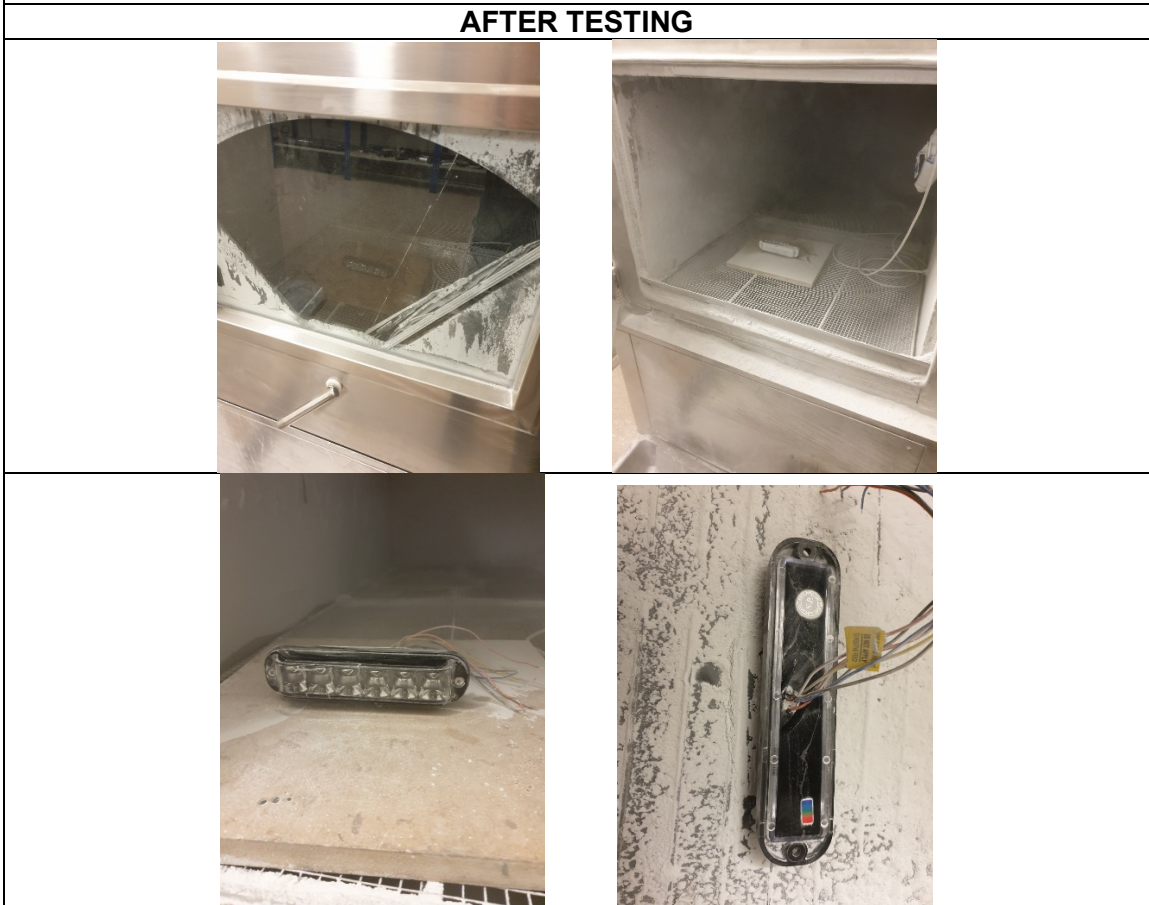
5. ATTACHMENTS HIGH PRESSURE DUST TEST

After testing, visual inspection showed no dust particle permeated into the unit.

Comments: Device passed IP6X test with no negative reaction. Lamp worked both at beginning of test cycle and after test complete. There was no ingress of dust within the lamp enclosure from vent position, side walls or cable entry (or any other area). On first inspection the silicone material does discolour slightly due to the layers of dust attached to the lamp however this can be easily cleaned / removed using water/cloth combination and is an expected condition on standard IP6X test. This is obviously a controlled test condition and not a standard use of the lamp therefore this is not expected when using the lamp within its intended installation conditions (ie white chalk/talcum powder will not be present).
