REDTRONIC IP69K TEST CERTIFICATE

Company : Redtronic Ltd
Address : Unit 1-9, Wellington Business Park, Quebec Street, Elland, HX5 9BX,
United Kingdom
Sample Name : BX62 GRILLE LAMP
Date Tested : 19th November 2019

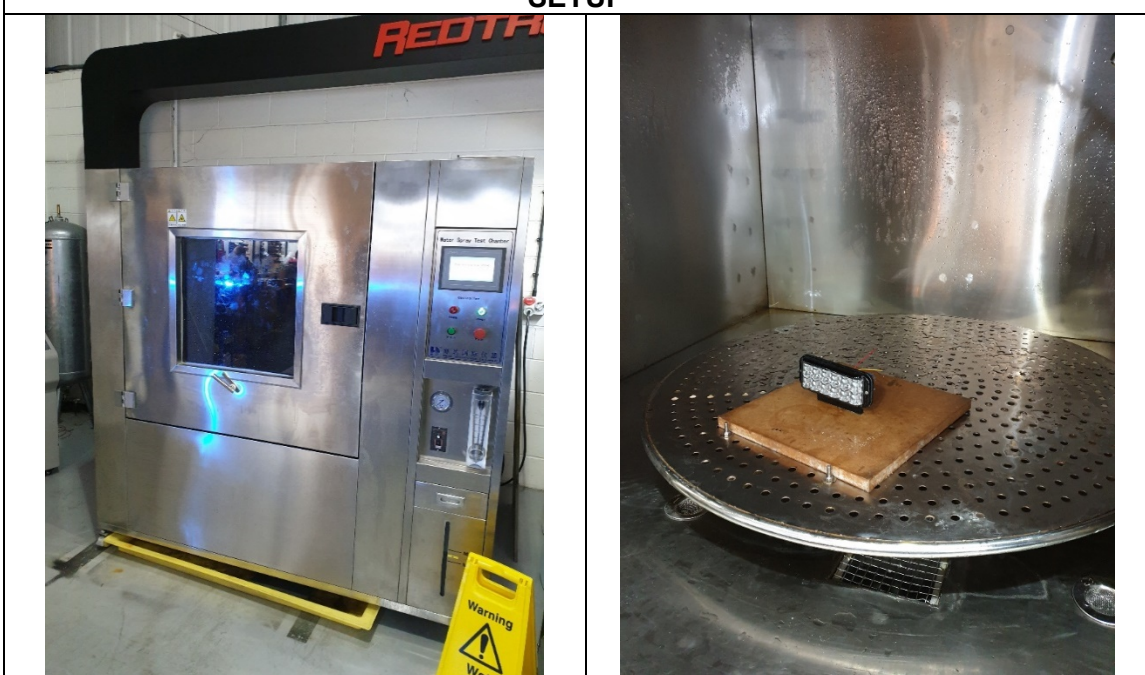
SETUP

Distance of the Nozzle to the specimen:	100 to 150mm
Water flow rate:	15l / min
Water pressure:	100 bar
Water temperature:	80°C
Speed test table:	5 U / min
Spray angle:	0°, 30°, 60°, 90°
Number of cycles:	1
Test Conditions:	The specimen is not in electrical operation.

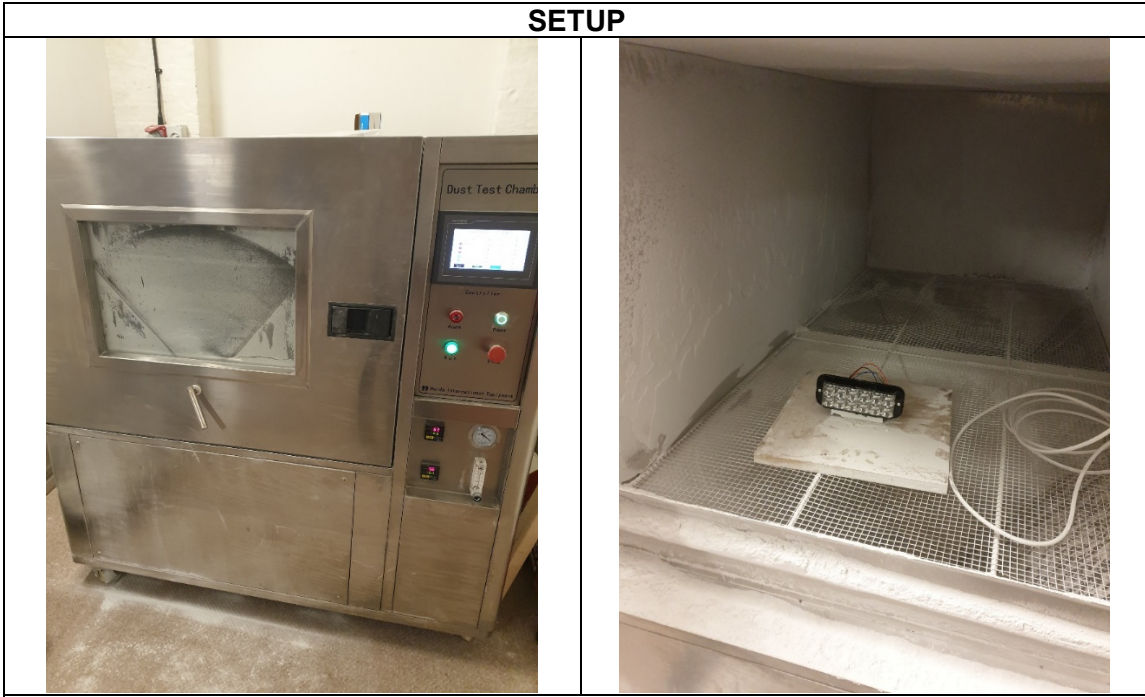
5. ATTACHMENTS HIGH PRESSURE DUST TEST

After testing, visual inspection showed no dust particle permeated into the unit.

Comments: Device passed IP6X test with no negative reaction. Lamp worked both at beginning of test cycle and after test complete. There was no ingress of dust within the lamp enclosure from vent position, side walls or cable entry (or any other area). On first inspection the silicone material does discolour slightly due to the layers of dust attached to the lamp however this can be easily cleaned / removed using water/cloth combination and is an expected condition on standard IP6X test. This is obviously a controlled test condition and not a standard use of the lamp therefore this is not expected when using the lamp within its intended installation conditions (ie white chalk/talcum powder will not be present).
