# REDTRONIC IP69K TEST CERTIFICATE

**Company** : Redtronic Ltd  
**Address** : Unit 1-9, Wellington Business Park, Quebec Street, Elland, HX5 9BX,  
United Kingdom  
**Sample Name** : BX32 GRILLE LAMP  
**Date Tested** : 19<sup>th</sup> November 2019

BS EN 60529:1992+A2:2013 – Degrees of protection provided by enclosures  
ISO 20653: 2013-02 IP6X: Dust Test  
ISO 20653: 2013-02: IPx9K high-pressure cleaning

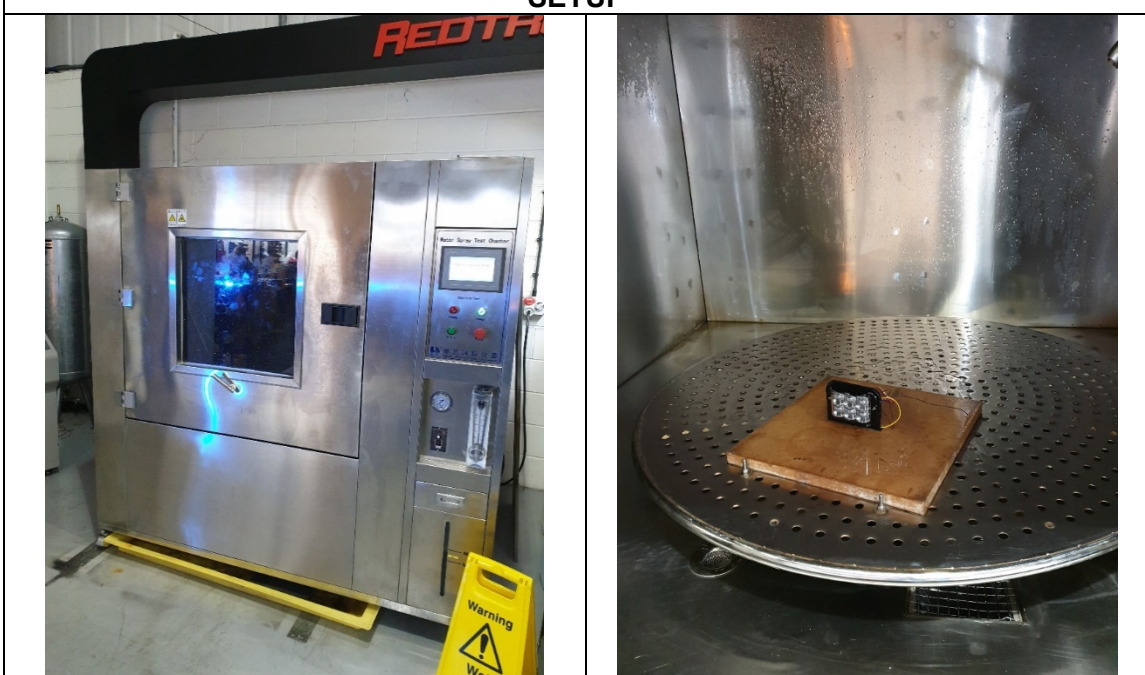
#### SETUP

Distance of the Nozzle to the specimen:	100 to 150mm
Water flow rate:	15l / min
Water pressure:	100 bar
Water temperature:	80°C
Speed test table:	5 U / min
Spray angle:	0°, 30°, 60°, 90°
Number of cycles:	1
Test Conditions:	The specimen is not in electrical operation.

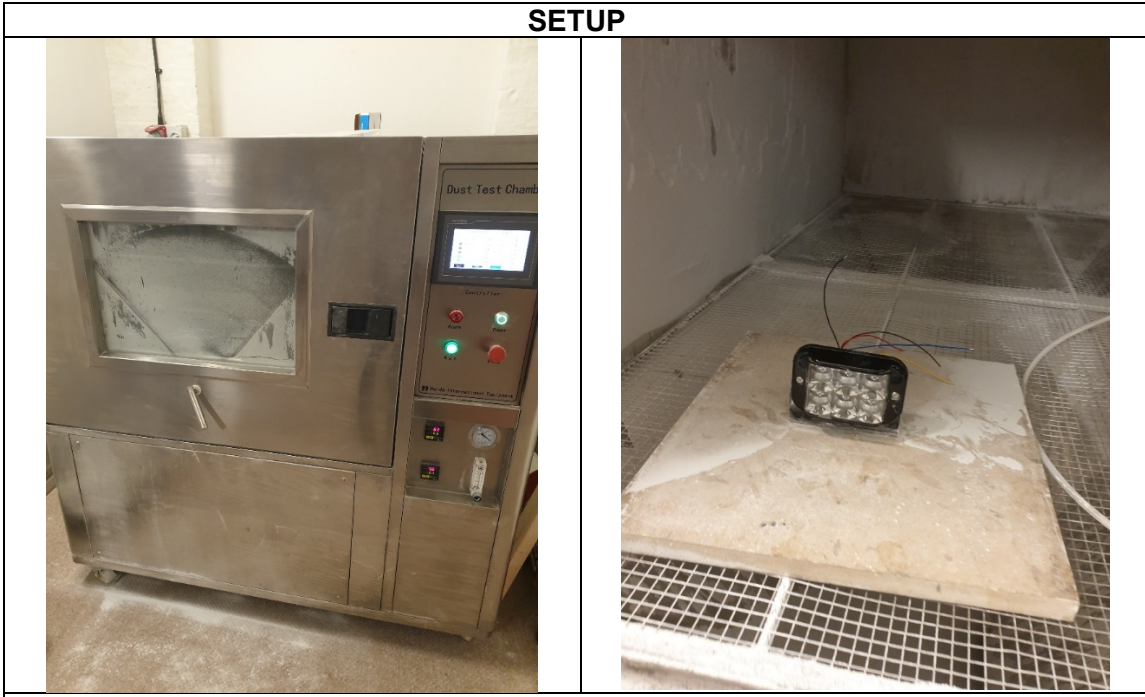
### 5. ATTACHMENTS HIGH PRESSURE DUST TEST

After testing, visual inspection showed no dust particle permeated into the unit.

Comments: Device passed IP6X test with no negative reaction. Lamp worked both at beginning of test cycle and after test complete. There was no ingress of dust within the lamp enclosure from vent position, side walls or cable entry (or any other area). On first inspection the silicone material does discolour slightly due to the layers of dust attached to the lamp however this can be easily cleaned / removed using water/cloth combination and is an expected condition on standard IP6X test. This is obviously a controlled test condition and not a standard use of the lamp therefore this is not expected when using the lamp within its intended installation conditions (ie white chalk/talcum powder will not be present).
